# Flooding in Wheatley: Potential for Natural Flood Management (NFM) in Littleworth

## 1 Introduction

## 2 Proposed location for NFM intervention in Littleworth

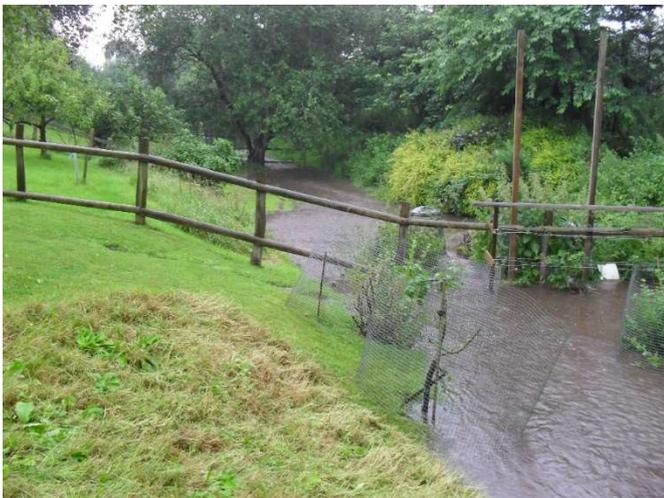
**Figure 1:** Flow down the railway cutting in Littleworth (during flood of July 2012).

Within the catchment of Wheatley Brook there is a disused railway cutting that runs through Littleworth. The construction of the railway cutting disrupted the local land drainage and during flooding events water flows down the railway cutting, see Figure 1.

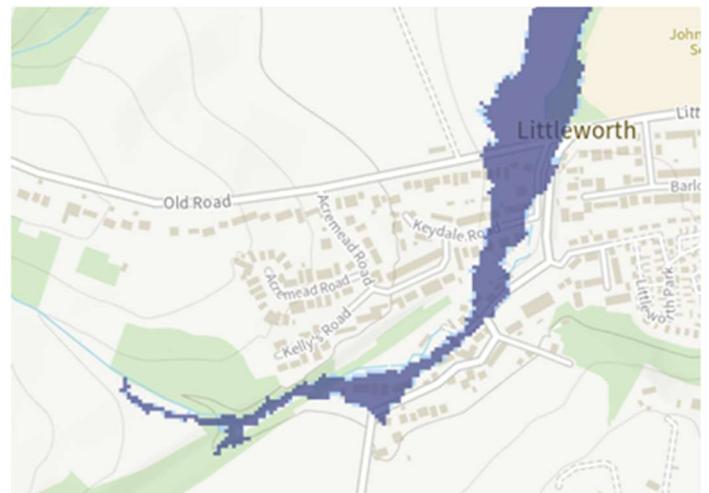
**Figure 2:** Flood Map for Littleworth showing the brook entering from the Northwest and running down along the cutting.

The lower part of the railway cutting is occupied by allotments but the upper part of the railway cutting is part of the Littleworth Nature Reserve. Most of the flood water in the railway cutting enters from a small brook that drains the area to the north-west of the railway cutting. Though the area of the catchment for this tributary is small, during intense rainfall it can contribute significant amounts of runoff, presumably due to its steep valley sides.

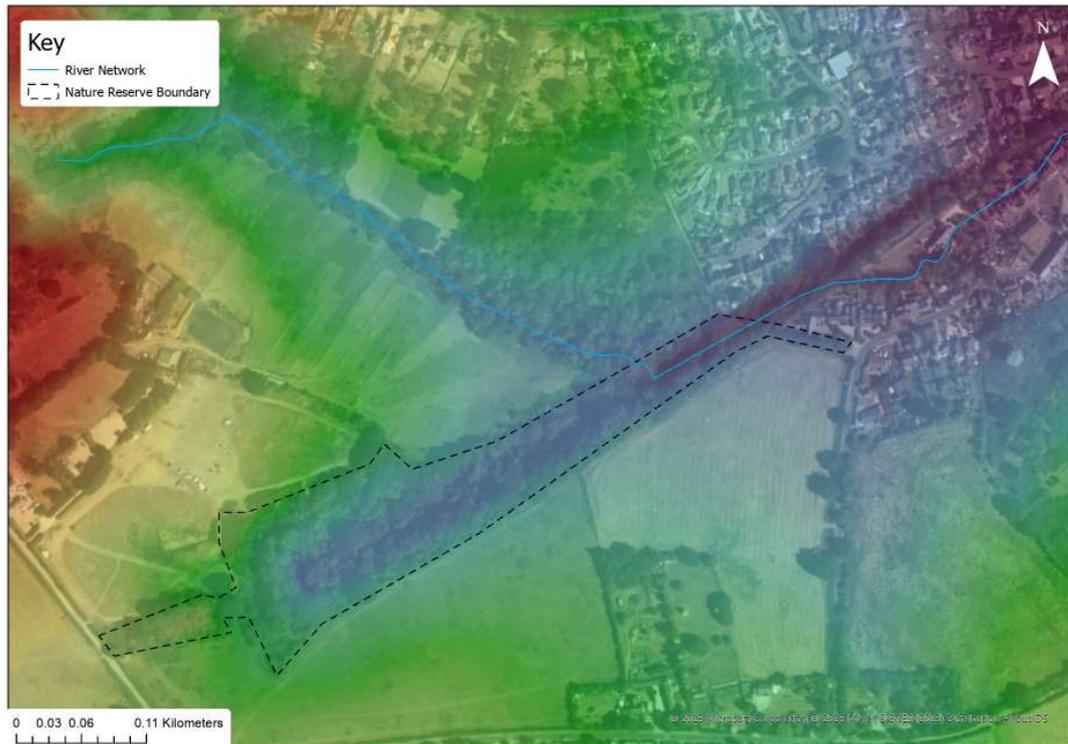
**Figure 3:** Map of the nature reserve boundary, overlaid onto LIDAR elevation data.

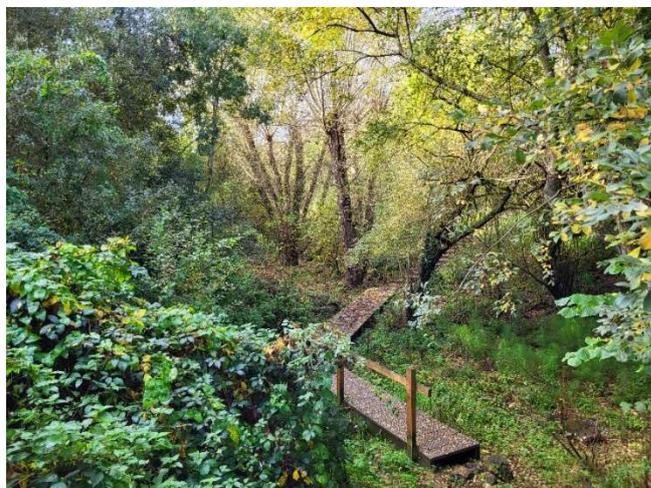
**Figure 4:** View of the Nature Reserve looking across the railway cutting where the footpath crosses the line. The base of the cutting slopes from left to right.

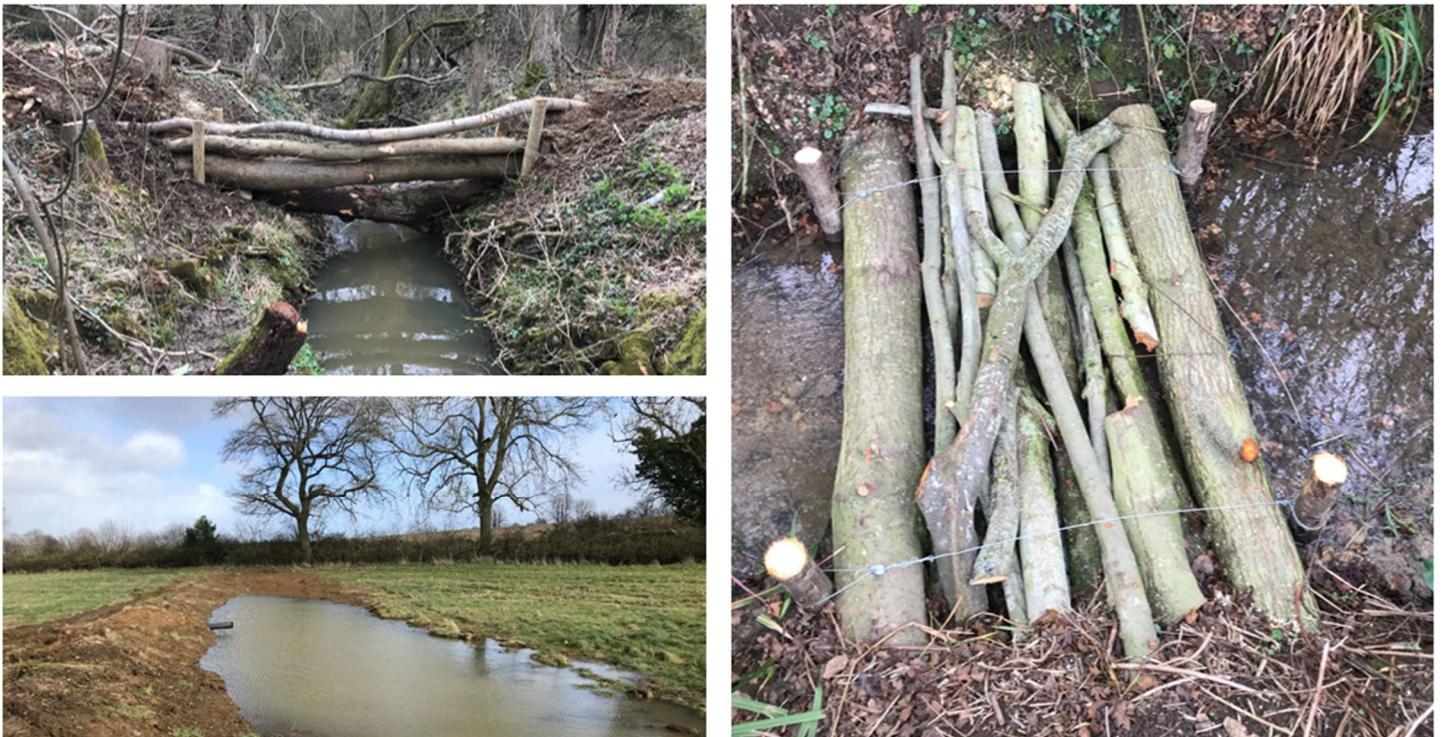
**Figure 5:** Example photographs of a leaky dam (top left), debris dam (right) and banded storage area (bottom left).

We are looking to create a series of NFM features along the railway cutting, to temporarily hold back water during storm events, starting from where the tributary enters the cutting, extending to the beginning of the allotments. Options for features include leaky dams, debris dams made from woody material and banded storage areas (see figure 5 for example photographs). It is envisaged that any NFM interventions would be to complement any flood storage provided further downstream in the catchment rather than an alternative.
